# GIANTLEAP

DELIVERABLE D1.5

Rejuvenation  
techniques for  
automotive fuel  
cells

**Project title:** Giantleap Improves Automation of Non-polluting Transportation with Lifetime Extension of Automotive PEM fuel cells

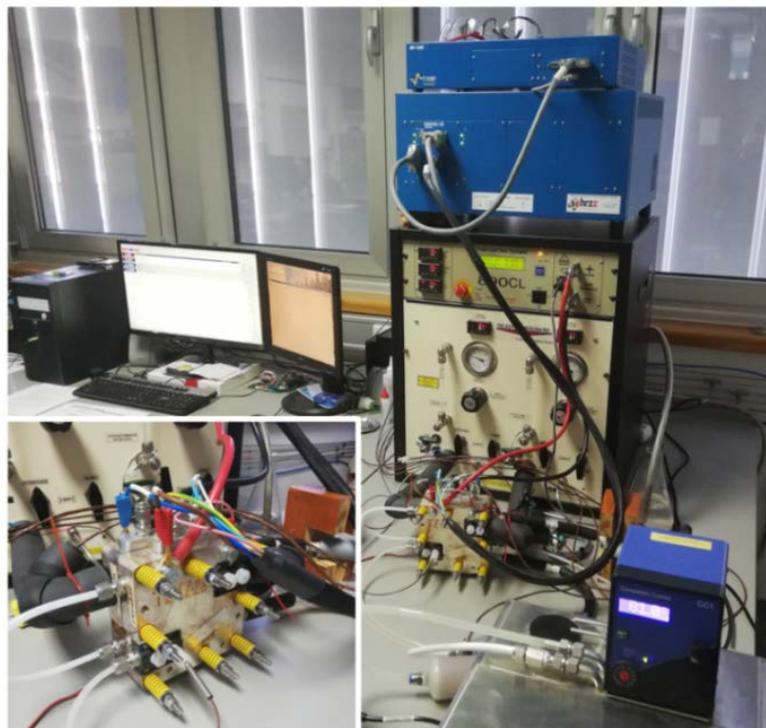
*Fig. 1. Experimental setup with investigated ElringKlinger's single PEM fuel cell (shown in insert).*

In order to investigate the recoverable phenomenon of catalyst layer degradation, and also correlate with the findings from the previous FCHJU project SAPHIRE and our previous Giantleap deliverable D1.4, the accelerated stress test (AST) with intentional interruptions has been performed at FESB's Laboratory for New Energy Technologies on an already conditioned 50 cm<sup>2</sup> active area single PEM fuel cell supplied by ElringKlinger (EK), using the same MEA configuration as it is used in the full size stacks in Giantleap project (Fig. 1).

This water-cooled single cell in co-flow configuration was exposed to an accelerated stress test for catalyst degradation. The AST designed to target electrocatalyst degradation, involves 40 seconds long potential cycling profile (Fig. 2) between voltages of 0.6 V for 10 s and 0.9 V for 30 s, which is slightly modified version of the U.S. Department of Energy (DoE) recommended AST protocol for electrocatalyst degradation [2]. Instead of cycling between 0.7 V and 0.9 V, cycling was conducted between 0.6 V and 0.9 V, in order to speed-up the degradation process. The loss of catalyst active area caused by Pt dissolution and sintering due to frequent voltage cycling was selected here as the target for the laboratory experiments as the most relevant for the fuel cell systems in automotive application. Similar test protocols were used in the SAPHIRE, Giantleap deliverable 1.4 and Ref. [1]. The voltage was imposed on the cell at 80 °C and 0.5 bar(g) via an external instrument (BioLogic SP-150 potentiostat/galvanostat) as the cell was in a non-operating ('driven') mode, i.e. nitrogen (N<sub>2</sub>) was used on the cathode and hydrogen (H<sub>2</sub>) on the anode side with constant flows of 0.4 SLPM and inlet relative humidities (RH) of 100% (dew point of 80 °C). The only differences, besides the intentional interruptions, from the AST protocol in the Giantleap deliverable D1.4 and Ref. [1] were the cell and gas temperatures, which were finally 80 °C, as DOE recommends, because our previous equipment limitations have been adjusted in the meantime.

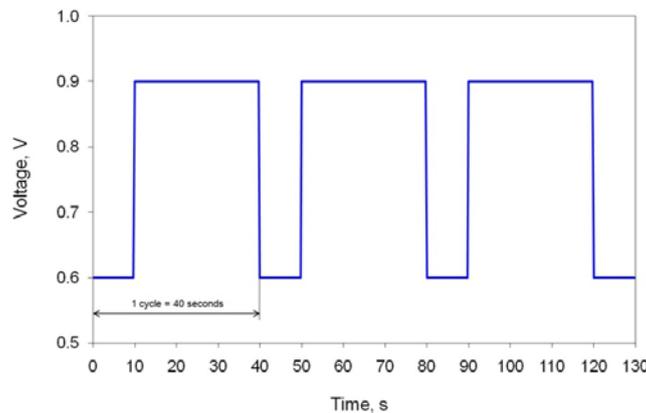
Fig. 2. Potential cycling profile used in accelerated stress test for electrocatalyst degradation.

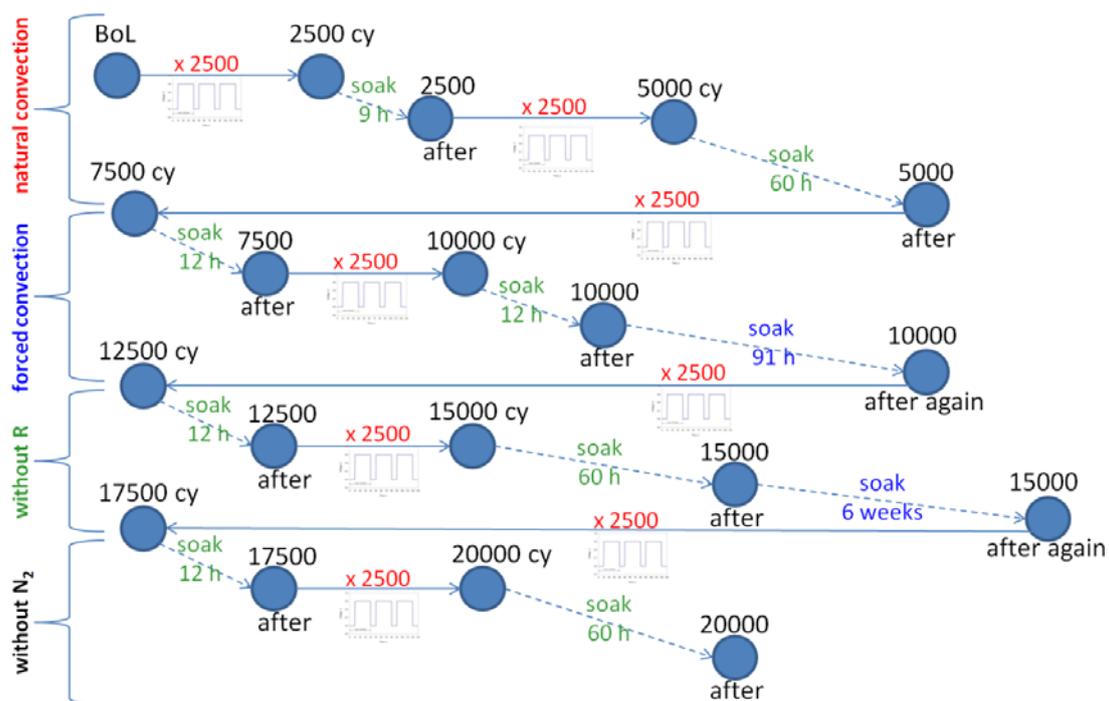
Fig. 3. The scheme of the complete rejuvenation testing schedule (blue circles represent diagnostics).

In general, the experiment was stopped every 2500 cycles for 9-12 h (as shorter overnight rest) or 60 h (as longer weekend rest), which was the intentional recovery period (so-called soak time step), and then the experiment was continued according to the same pattern until 20000 cycles. Before and after every intentional stop (and after conditioning of 1 h after subsequent startup), a series of standard laboratory diagnostic procedures was performed in order to monitor performance degradation and recovery. These diagnostic methods include polarization curves, electrochemical impedance spectroscopy (EIS), cyclic voltammetry (CV), and linear sweep voltammetry (LSV). In addition, a few deviations from this general schedule were occurred during the whole test: the complete diagnostics were intentionally performed after an additional soak time step of 91 h at 10000 cycles and after additional 6 weeks of rest at 150000 cycles, which was done in order to track the eventual change of performance with additional shutdowns and without additional AST cycles. The scheme of the complete rejuvenation testing schedule (4 weeks of intensive testing) is given in Fig. 3.

As it is also shown in Fig. 3, different shutdown procedures were changed every 5000 cycles during the conducted AST, in order to test their impact on performance recovery phenomenon. Their differences are given in more detail in Tab. 2.

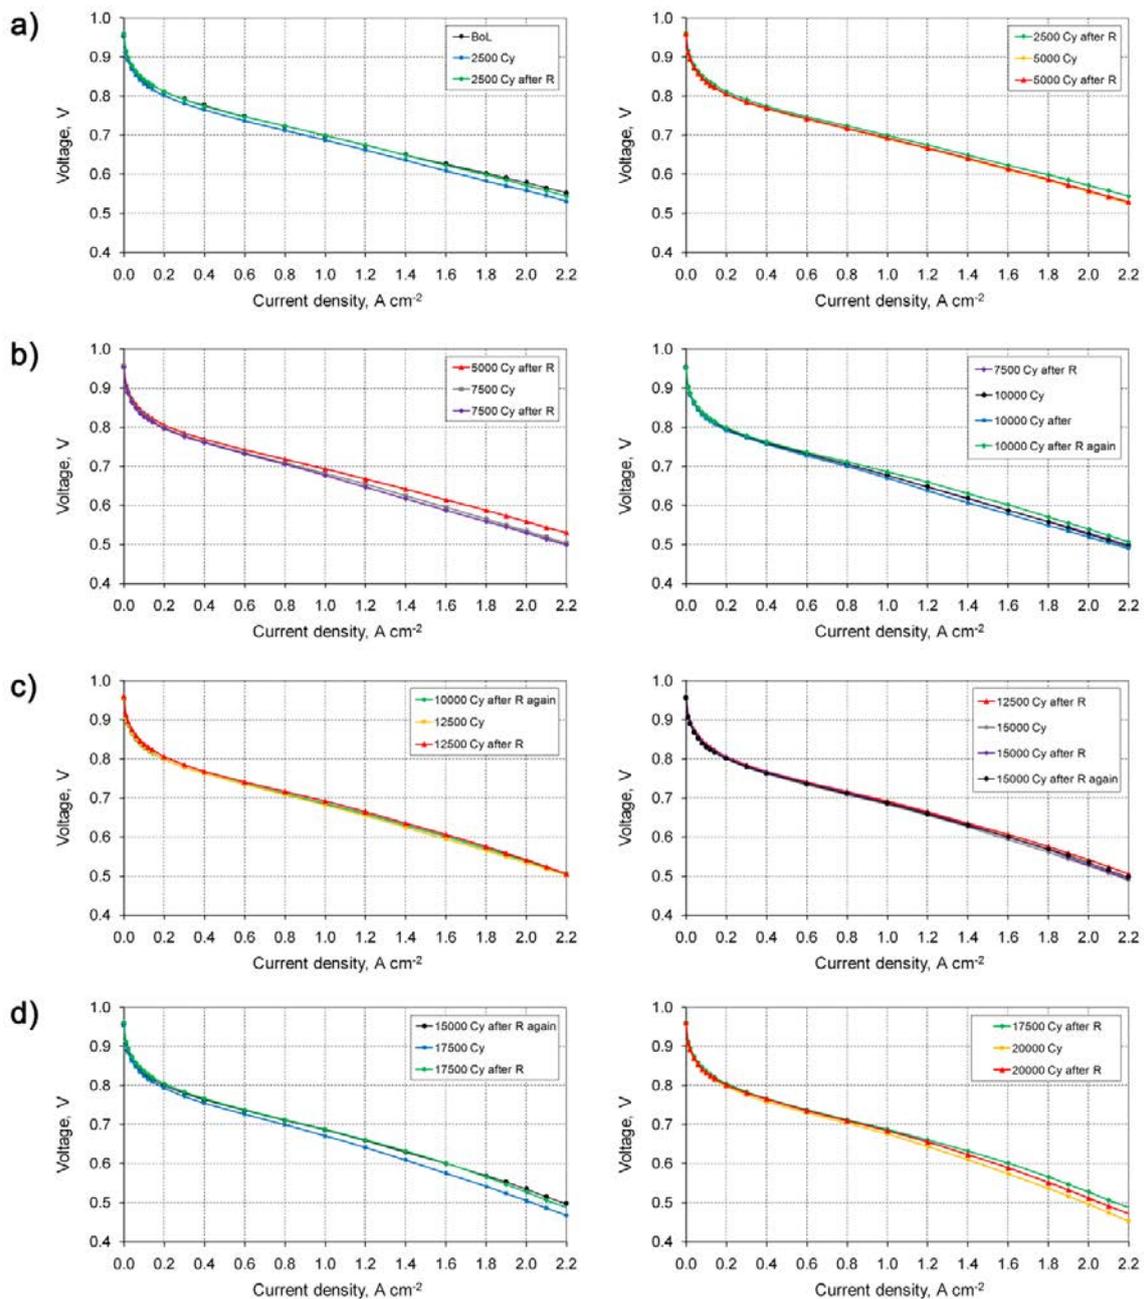
Fig. 4. Comparison of measured polarization curves during the accelerated stress test according to the performed shutdown procedure and various soak time steps: a) 'natural convection' with rests of 9 h (left) and 60 h (right); b) 'forced convection' with rests of 12 h (left) and 12 h with additional 91 h rest (right); b) 'without R' with rests of 12 h (left) and 60 h with additional 6 weeks rest (right); d) 'without N<sub>2</sub>' with rests of 12 h (left) and 60 h (right).

The resulting averaged polarization curves obtained at the beginning of life (BoL), and before and after every intentional stop during the conducted AST are shown in Fig. 4. The obtained curves are separated according to the four different shutdown procedures, which were changed every 5000 cycles, and then according to the various duration of the soak time step.

From the plotted polarization curves, degradation and rejuvenation are noticeable, which means that not all of exhibited degradation is permanent, but they may be quantified if the cell potential at different current densities is plotted vs. time or vs. number of cycles, as shown in Fig. 5.

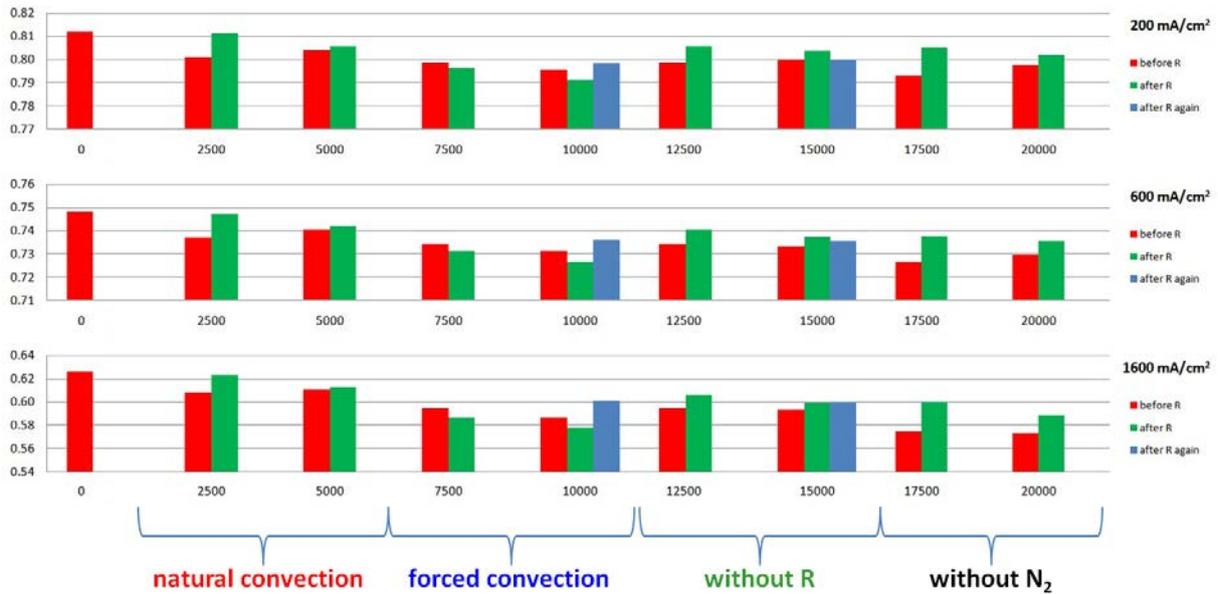
Fig. 5. Degradation and rejuvenation at different current densities during the accelerated stress test extracted from the measured polarization curves.

In general, degradation and rejuvenation are more pronounced at higher current densities. However, rejuvenation obviously depends on the duration of the soak time step. During the first 5000 cycles, while the ‘natural convection’ as the shutdown procedure was performed, significant recovery after 2500 cycles (shorter overnight rest) and almost negligible recovery after 5000 cycles (longer weekend rest) is noticeable. During the next 5000 cycles, while the ‘forced convection’ as the shutdown procedure was performed, there was no recovery after 7500 cycles (shorter overnight rest) and after 10000 cycles (shorter overnight rest), but there was significant recovery after additional soak time step of 91 h. During the next 5000 cycles, while the ‘without R’ as the shutdown procedure was performed, there was noticeable recovery after 12500 cycles (shorter overnight rest) and small recovery after 15000 cycles (longer weekend rest), but there was no recovery after additional soak time step of 6 weeks. During the last 5000 cycles, while the ‘without N<sub>2</sub>’ as the shutdown procedure was performed, there was significant recovery after 17500 cycles (shorter overnight rest) and visible recovery after 20000 cycles (longer weekend rest), but there was no recovery after additional soak time step of 6 weeks.

From the results of the polarization curves analysis, it could be concluded that the overnight cell rest results in more intensive recovery than cell rest over weekend, which means that ‘too much rest’ is not generally recommended. However, shutdown procedure ‘without N<sub>2</sub>’ proved to be the most effective for performance recovery, especially after the shorter overnight rest.

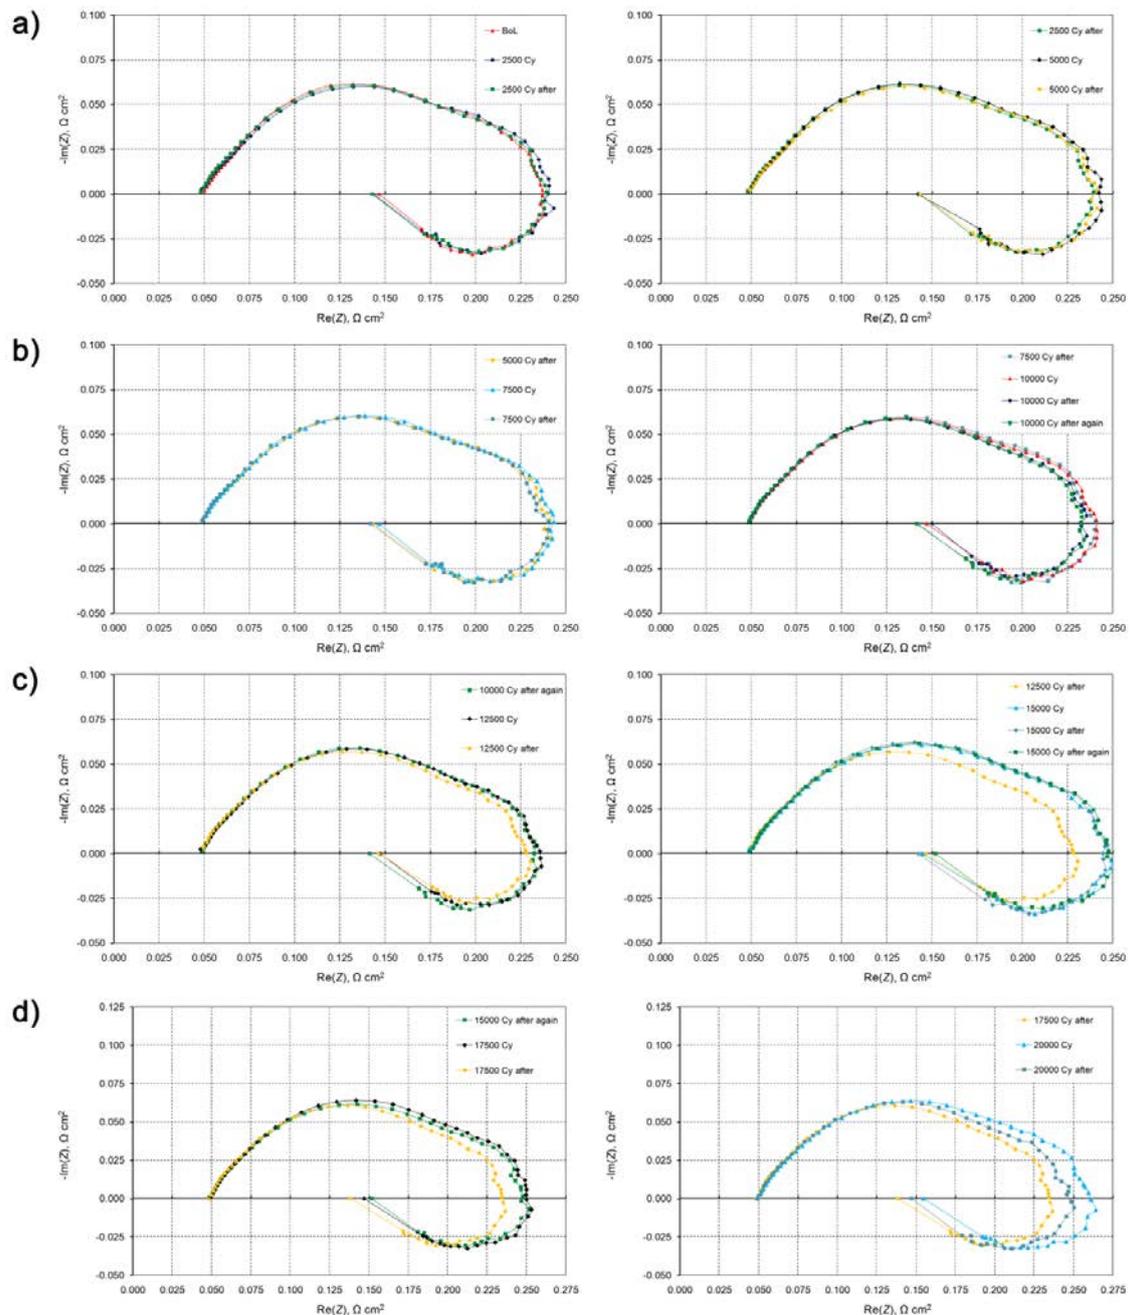
Fig. 6. Comparison of measured impedance spectra during the accelerated stress test according to the performed shutdown procedure and various soak time steps: a) 'natural convection' with rests of 9 h (left) and 60 h (right); b) 'forced convection' with rests of 12 h (left) and 12 h with additional 91 h rest (right); b) 'without R' with rests of 12 h (left) and 60 h with additional 6 weeks rest (right); d) 'without N<sub>2</sub>' with rests of 12 h (left) and 60 h (right).

The resulting Nyquist plots obtained at the beginning of life (BoL), and before and after every intentional stop during the conducted AST are shown in Fig. 6. The obtained impedance spectra are separated according to the four different shutdown procedures, which were changed every 5000 cycles, and then according to the various duration of the soak time step.

The results of the EIS measurements taken during the AST have similar trends as the polarization curves, but differences between the all EIS curves in Fig. 6 are almost insignificant for a more detailed discussion. However, the semicircles' high-frequency branches, in general, are more tilted/distorted with degradation, indicating an increase in the catalyst layer (CL) ionic resistance, while the low-frequency loops, representing mass transport losses, are getting bigger. As a result, the rightmost real-axis intercept on the Nyquist diagram around 0.5 Hz or lower (the point with maximum real impedance and the highest resistive losses), defined as the total resistance (Total R) or LF intercept, increased most significantly (Fig. 7), while the membrane resistance (the leftmost real-axis intercept at high frequencies) showed a slight increase, as the EIS measurements were performed with not fully-hydrated reactants (83.4% RH). Therefore, there is a mixture of increase in activation losses (related to the loss of the cathode electrochemical active surface area, ECSA) and mass transport losses, which concurs also with the findings (at least qualitatively) of cycling voltammetry (subsection 3.3). On the other hand, due to rejuvenation of the fuel cell during the intentional recovery periods, impedance spectra also show some reversibility, i.e. reduction/improvement of the impedance curves, which is mostly pronounced at LF intercept (Fig. 7). Therefore, in Fig. 7 there is an evident increase of LF intercept value after every degradation step, and decrease after every soak time step. Again, shutdown procedure 'without N<sub>2</sub>' proved to be the most effective for performance recovery, especially after the shorter overnight rest.

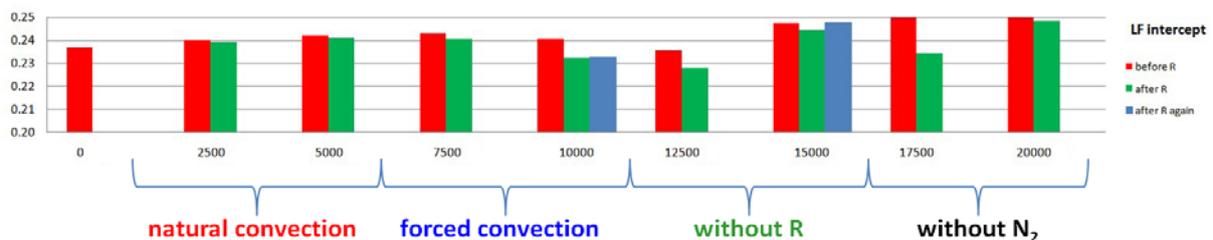
Fig. 7. Degradation and rejuvenation during the accelerated stress test extracted from the measured impedance spectra at low-frequency intercept.

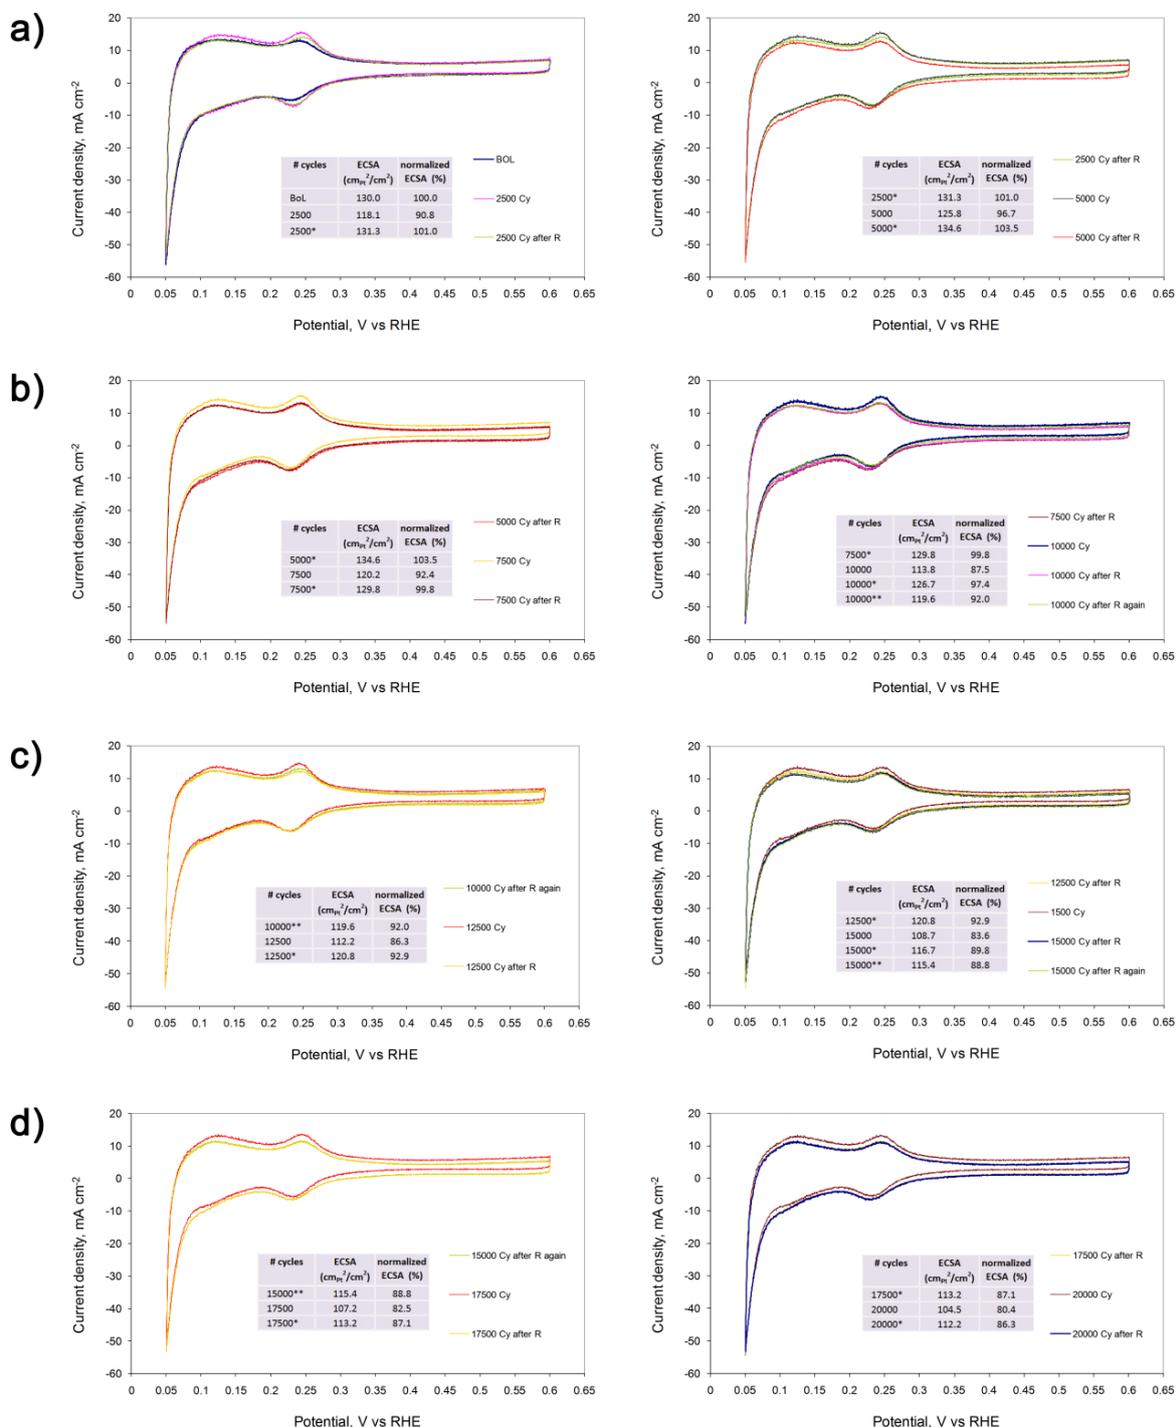
Fig. 8. Comparison of cyclic voltammograms and calculated ECSA values during the accelerated stress test according to the performed shutdown procedure and various soak time steps: a) 'natural convection' with rests of 9 h (left) and 60 h (right); b) 'forced convection' with rests of 12 h (left) and 12 h with additional 91 h rest (right); b) 'without R' with rests of 12 h (left) and 60 h with additional 6 weeks rest (right); d) 'without N<sub>2</sub>' with rests of 12 h (left) and 60 h (right).

The results of the CV measurements obtained at the beginning of life (BoL), and before and after every intentional stop during the conducted AST are shown in Fig. 8. The obtained cyclic voltammograms with the calculated ECSA values and their loss in percentage during the AST are separated according to the four different shutdown procedures, which were changed every 5000 cycles, and then according to the various duration of the soak time step.

As intended, CVs indicated a loss of the ECSA during the degradation periods probably caused by platinum dissolution due to intentional frequent voltage cycling during the AST, but total obtained degradation during the AST is still under the target of the DOE protocol for CV (i.e. at least 40% loss of initial active area). The loss of the ECSA apparently resulted in structural changes within the catalyst layer, as the increase in resistance and in mass transport suggests from the previous polarization curves and EIS analyses. On the other hand, due to rejuvenation of the fuel cell during the intentional recovery periods, CVs also show reversibility, i.e. increase/improvement of the ECSA (Fig. 9). Therefore, in Fig. 9 there is an evident decrease of ECSA value after every degradation step, and increase after every soak time step. During the additional soak time step of 91 h rest after 10000 cycles, there was decrease

of ECSA, but during the additional soak time step of 6 weeks rest after 15000 cycles, there was almost no change.

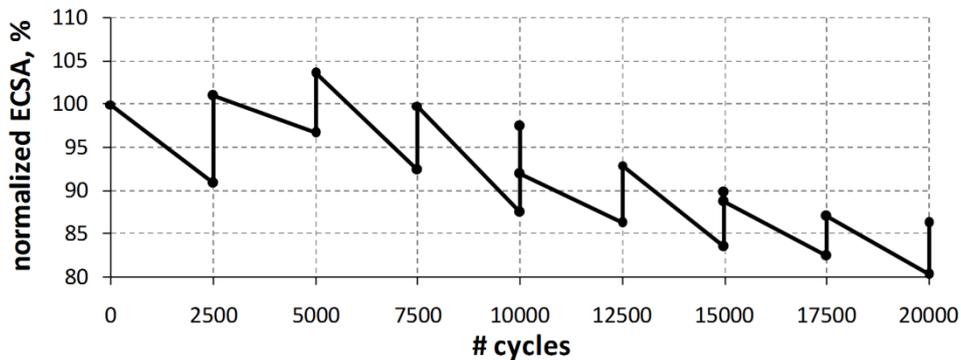
Fig. 9. Change of the ECSA normalized values during the accelerated stress test calculated from the measured cyclic voltammograms.

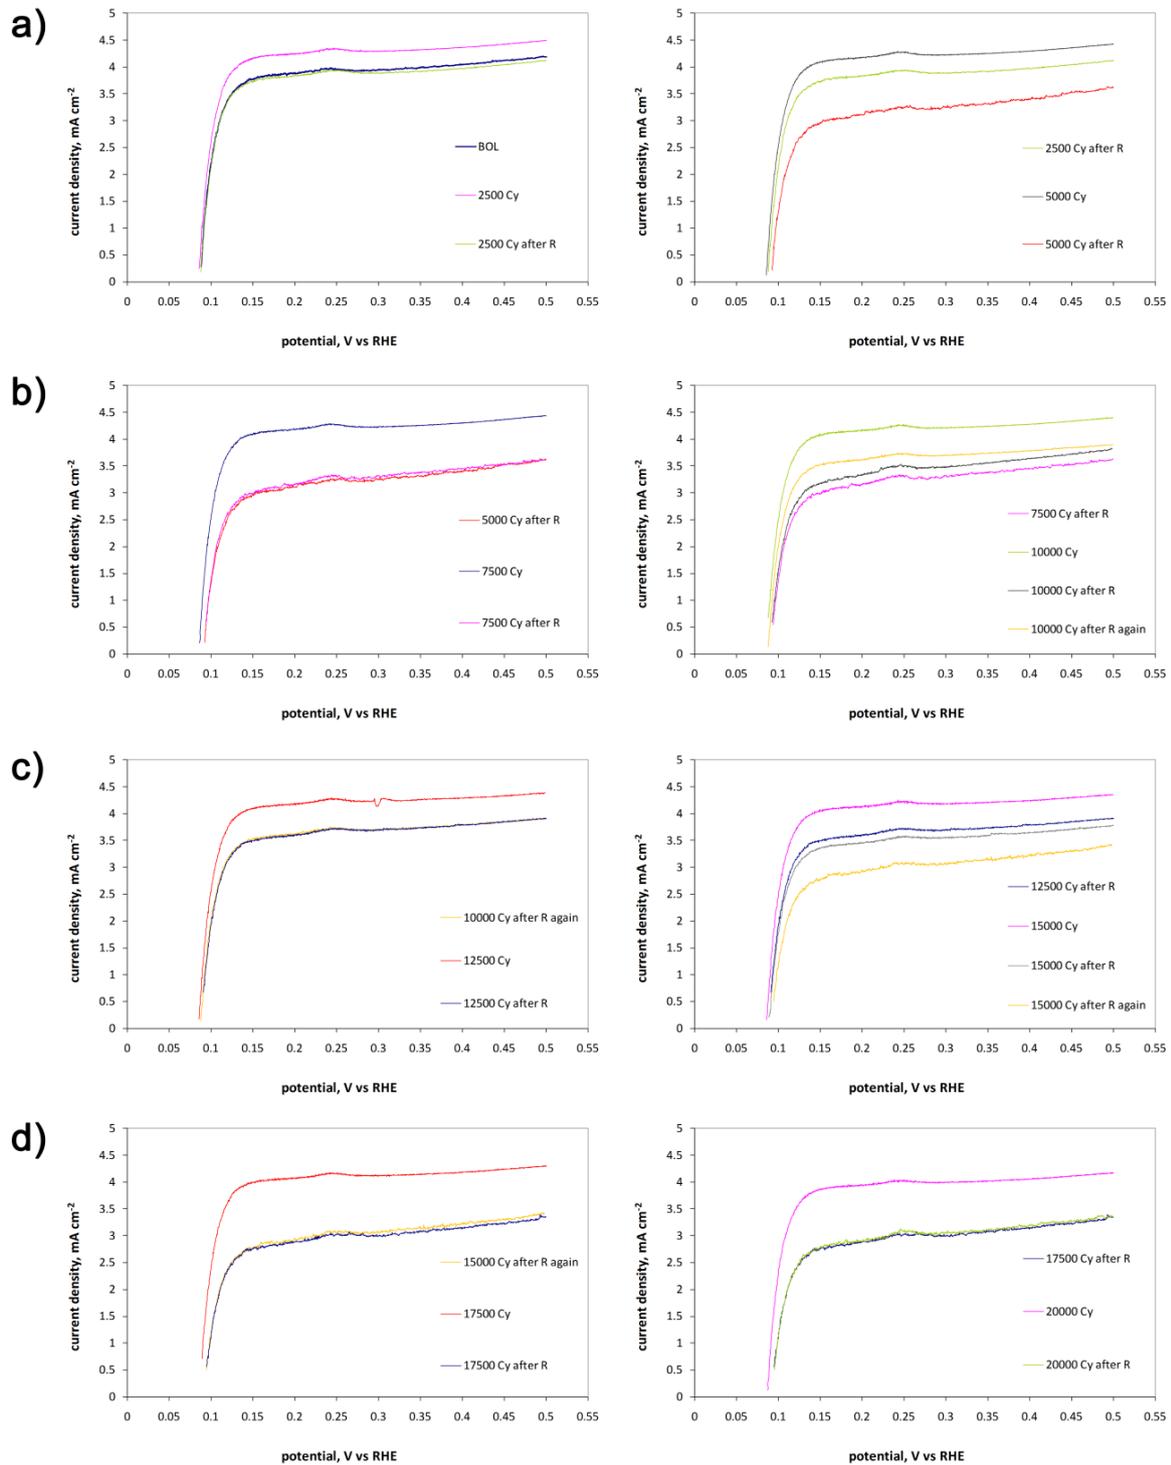
Fig. 10. Comparison of linear sweep voltammograms during the accelerated stress test according to the performed shutdown procedure and various soak time steps: a) 'natural convection' with rests of 9 h (left) and 60 h (right); b) 'forced convection' with rests of 12 h (left) and 12 h with additional 91 h rest (right); b) 'without R' with rests of 12 h (left) and 60 h with additional 6 weeks rest (right); d) 'without N<sub>2</sub>' with rests of 12 h (left) and 60 h (right).

The results of the LSV measurements obtained at the beginning of life (BoL), and before and after every intentional stop during the conducted AST are shown in Fig. 10. The obtained linear sweep voltammograms are separated according to the four different shutdown procedures, which were changed every 5000 cycles, and then according to the various duration of the soak time step.

The results of the LSV measurements, in this kind of AST in general, indicate that hydrogen crossover does not change significantly during the uninterrupted AST, because this kind of AST targeted degradation of the catalyst and there is no reason for hydrogen crossover to change significantly. In Fig. 10, hydrogen crossover was indeed more or less constant around  $4 \text{ mA cm}^{-2}$  after every degradation step during the AST. However, conducted AST was intentionally interrupted with the soak time steps every 2500 cycles. Therefore, hydrogen crossover was decreasing after every soak time step during the AST (it was between  $3$  and  $3.5 \text{ mA cm}^{-2}$ ), which suggest that cause of the reversible degradation could be accumulated water within the cell and/or presence of oxygen within the CL. Also, hydrogen crossover generally showed more intensive decrease after the longer soak time step. During the additional soak time step of 91 h rest after 10000 cycles, there was increase of hydrogen crossover, but during the additional soak time step of 6 weeks rest after 15000 cycles, there was an evident decrease.
